Ice Jam at the Rio Blanco Diversion Weir on the White River in Colorado

A Case Study of In-Stream Structures and Ice

Andrew M. Tuthill

February 2008

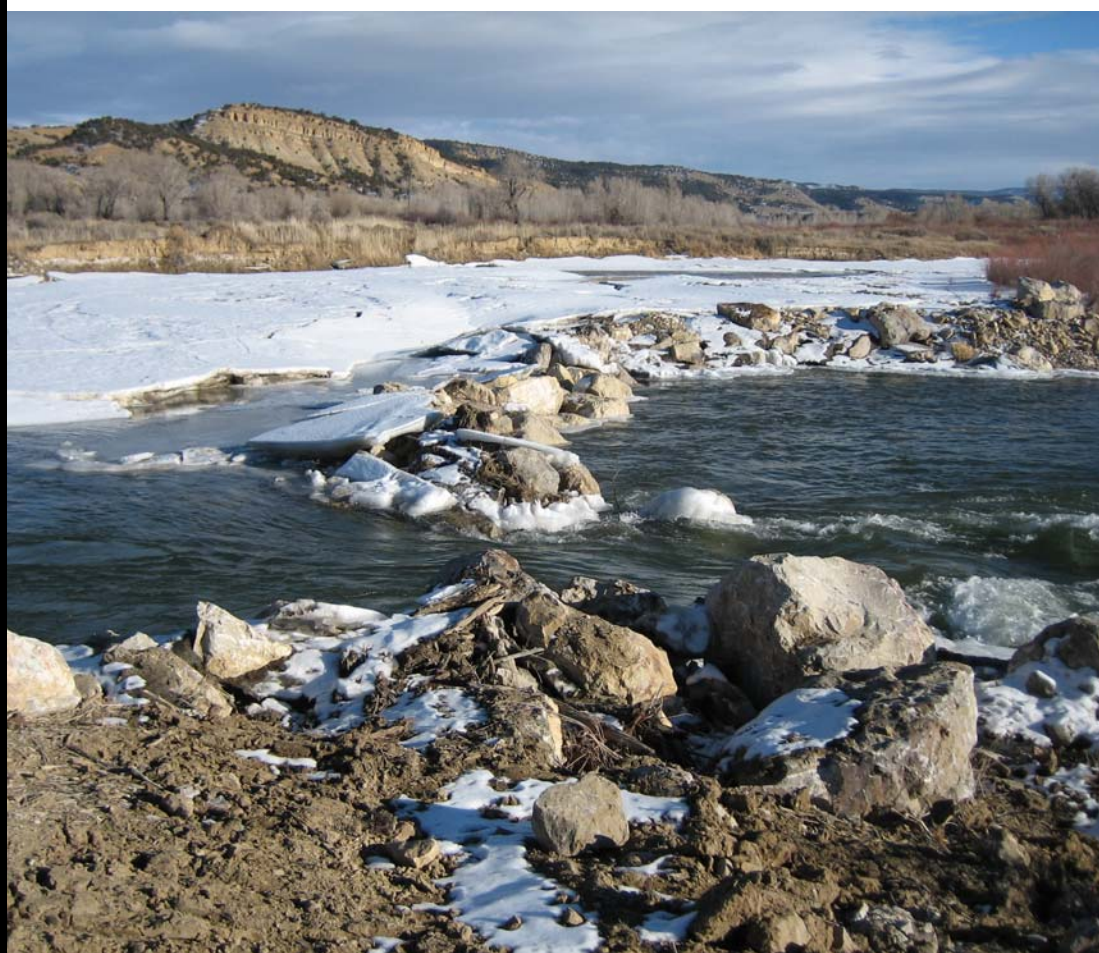
COVER: Breached rock weir on Colorado's White River, about 18 miles south of Meeker.

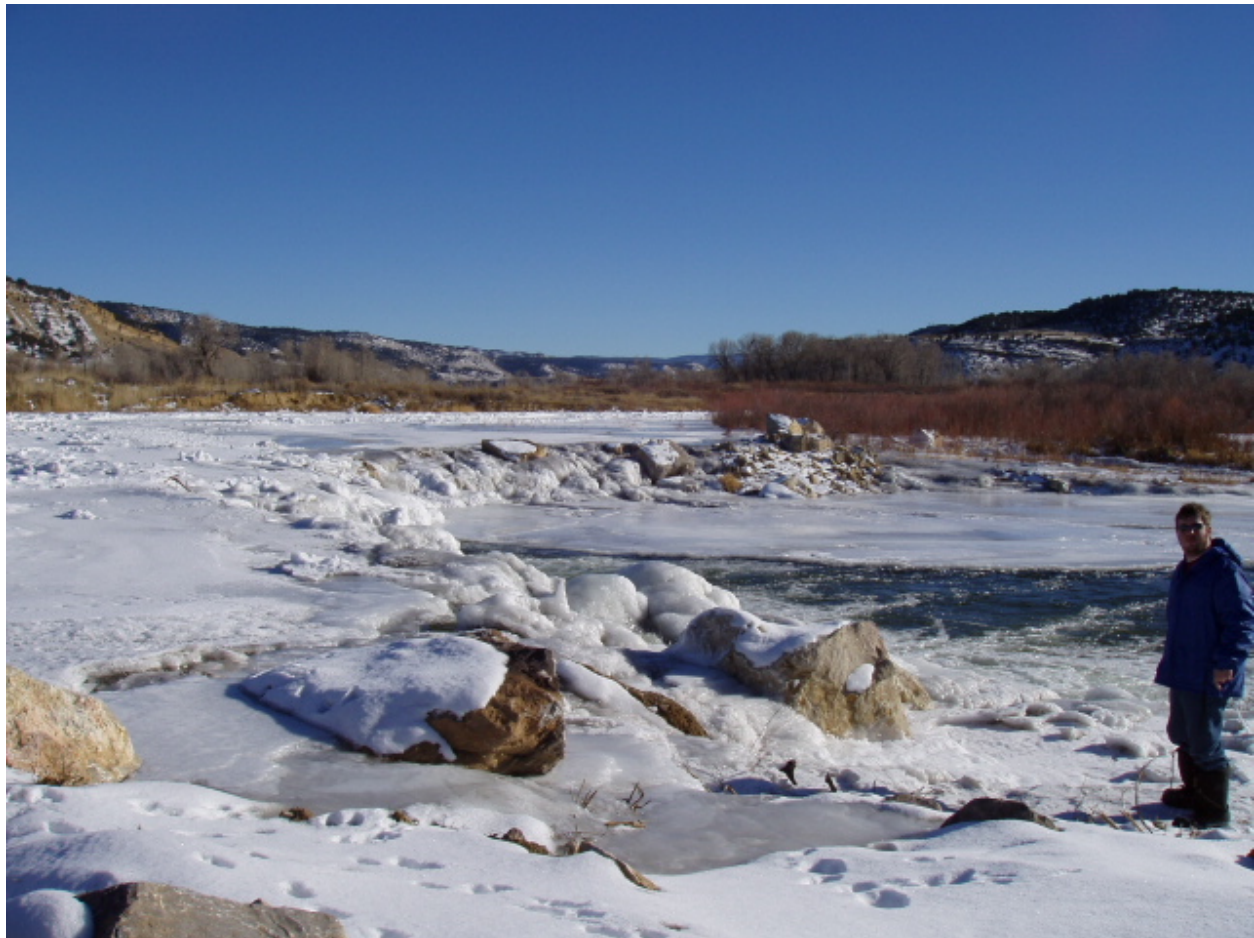
The freezeup ice jam formed during an early December cold snap at the rock weir structure that diverts water to Rio Blanco Lake. Figure 4 shows the jam at the structure on 15 December 2005.

Figure 4. Ice jam at CDOW weir on 15 December 2005.

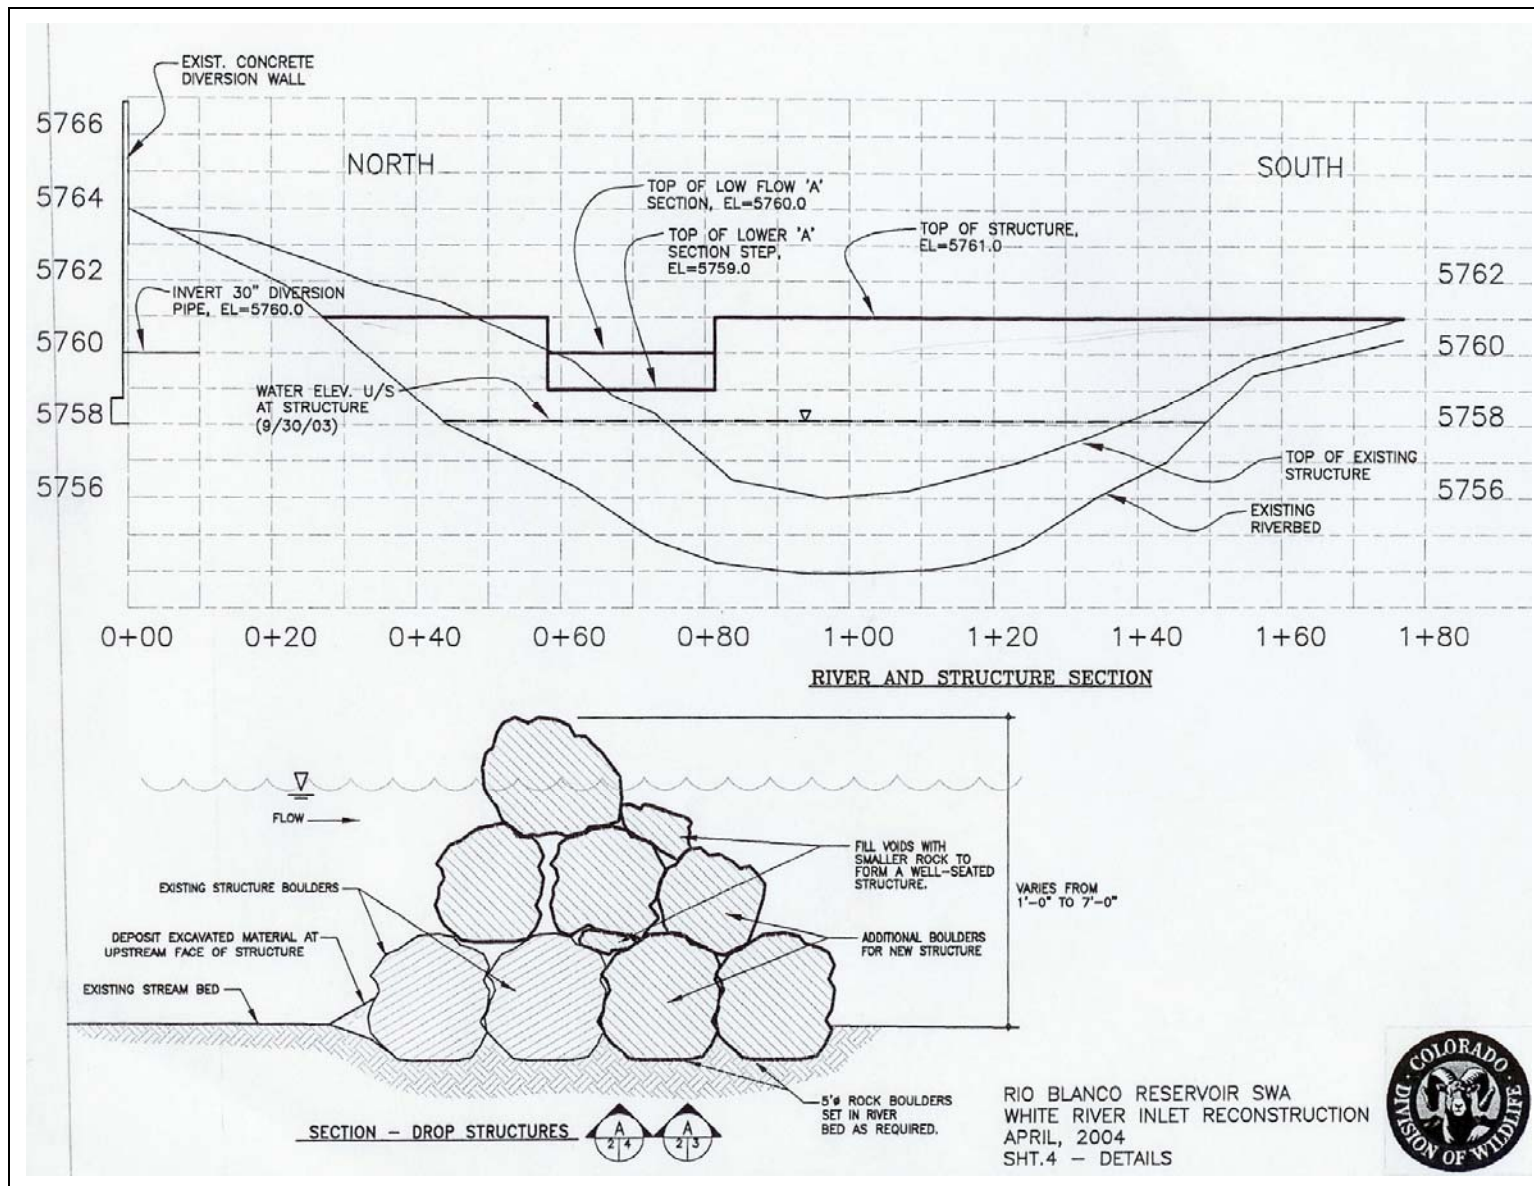
In the fall of 2005, the weir had been redesigned and heightened about 4 ft to better divert flow into the Rio Blanco Lake. Figure 5 shows before and after cross sections of the weirs. The new weir had a level crest with a lower 25-ft-wide spillway section, whereas the previous weir was more U-shaped, conforming to the natural riverbed cross section. Under low flow, open water conditions, the design change resulted in a water level rise at the weir of about 2 ft.

Figure 5. Section views of CDOW rock weir.

Figure 4 shows before-and-after weir cross sections. The previous structure was about 2 ft high at its lowest point, with a U-shaped cross section roughly parallel to the existing river bed. At low flows, the depth upstream of the weir was about 4 ft, the water surface width was about 65 ft, and the cross-sectional flow area at the weir crest was about 80 ft². The new structure increased the design low-flow open-water depth to about 6 ft, with flow passing through a 23-ft-wide by 2-ft-deep cutout spillway section. Based on Figure 3, the flow area through the new spillway section is about 20 ft². With the spillway crest ice-clogged as shown in Figure 2, the upstream water surface elevation is about level with the new weir crest, giving a water depth of about 6 ft. Assuming an average bed slope of 0.00395¹ upstream of the weir, this 3-ft increase in water surface elevation would extend the low flow backwater distance from about 500 ft to 1260 ft.

Based on the CDOW weir cross sections (Fig. 5), water velocities on the pool upstream of the weir were calculated assuming an average winter baseflow of 350 cfs. Three cases were considered: 1) a no-weir case, 2) a pre-2005 weir case, and 3) a 2005 and after weir case.

- 1) For the no-weir case, assuming a top width of 70 ft and an average depth of 1.5 ft, the average velocity would be 3.3 ft/s. Under these conditions, one would expect the frazil floes to pass the pool and the 70-ft weir opening without problems as they do in the upstream river channel between the town of Meeker and the Rio Blanco weir.
- 2) For the pre-2005 weir case, with a top width of about 60 ft and an average upstream depth of about 2.5 ft, the approach velocity would be 2.3 ft/s, which would still favor ice passage rather than retention.
- 3) For the 2005 weir, with an upstream top width of about 130 ft and an average upstream water depth of 4 ft, the upstream approach velocity would be about 0.7 ft/s. This is slow enough for the frazil ice floes to stall in the upstream pool independent of the 30-ft gap width at the weir (which would probably cause arching).

Based on these observations, to ensure against ice jam formation, it would probably be necessary to lower the pool elevation by about 2 ft (close to pre-2005 conditions) and maintain a gap width of at least 60 ft.

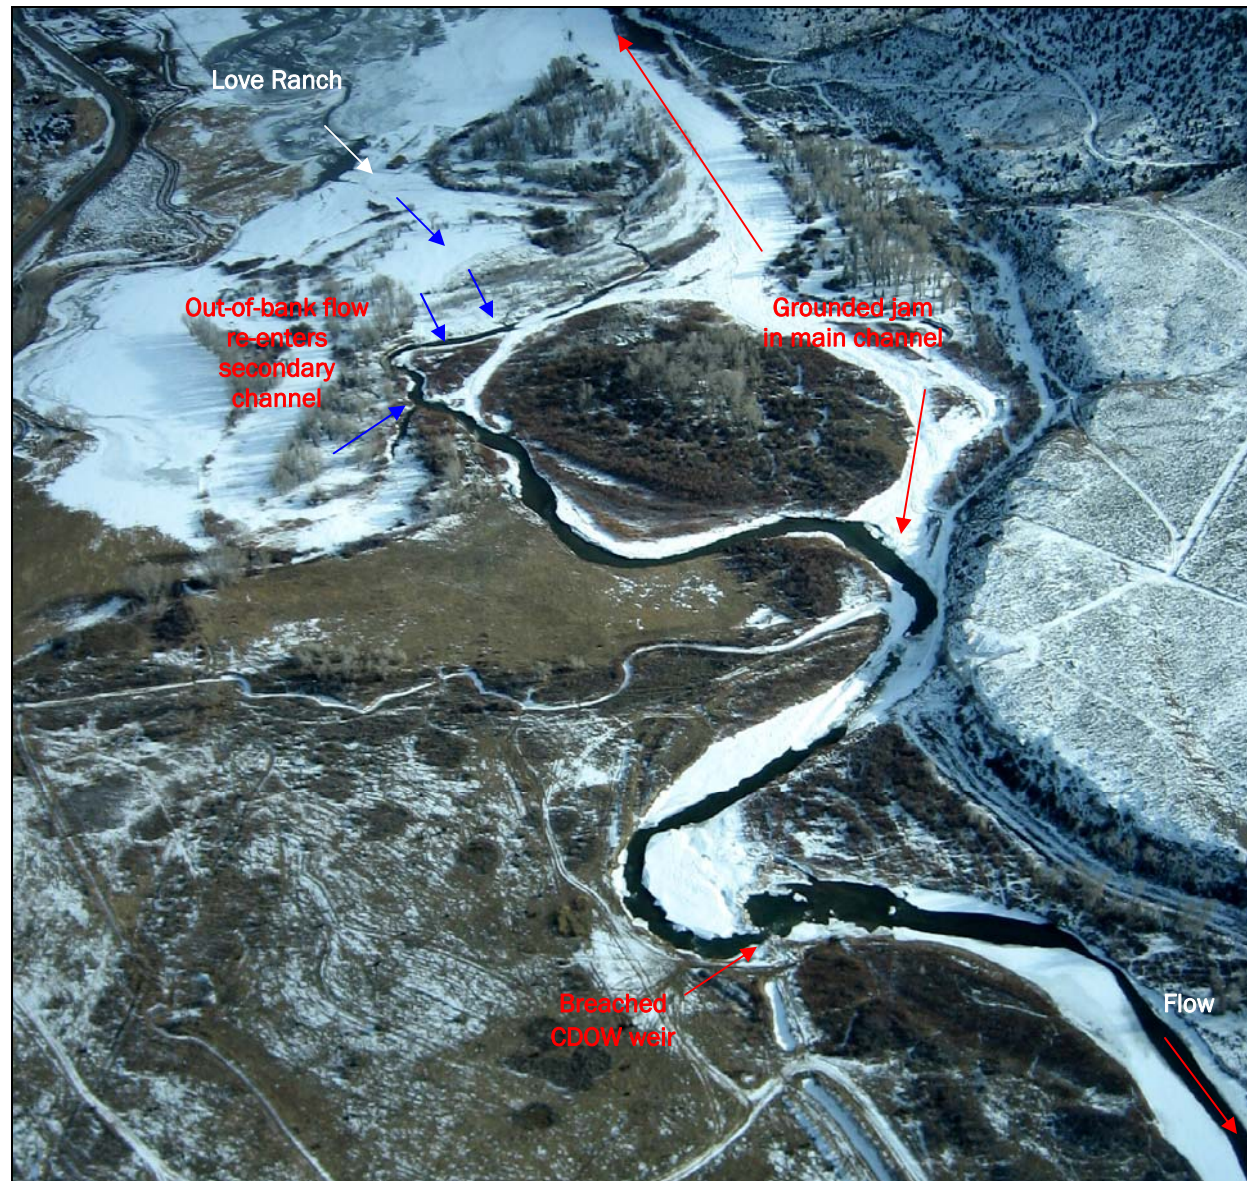
Below the Love property, the out-of-bank flow entered a wetland, which drained into a secondary channel that then conveyed nearly all the flow (Fig. 7). Because almost no flow passed beneath the grounded jam in the main channel, very little melting had taken place by mid-January, even though the air temperatures had been moderate (Fig. 10 and 11). Records from the USGS gage below Meeker indicate that an ice cover existed at the gage site, eight miles upstream of the CDOW weir, from 29 November to 30 December 2005 (Fig. 3). Whether this ice cover in the vicinity of the gage retained or passed frazil ice from upstream is uncertain. By mid-

Figure 7. White River downstream of Love property, 17 January 2006.

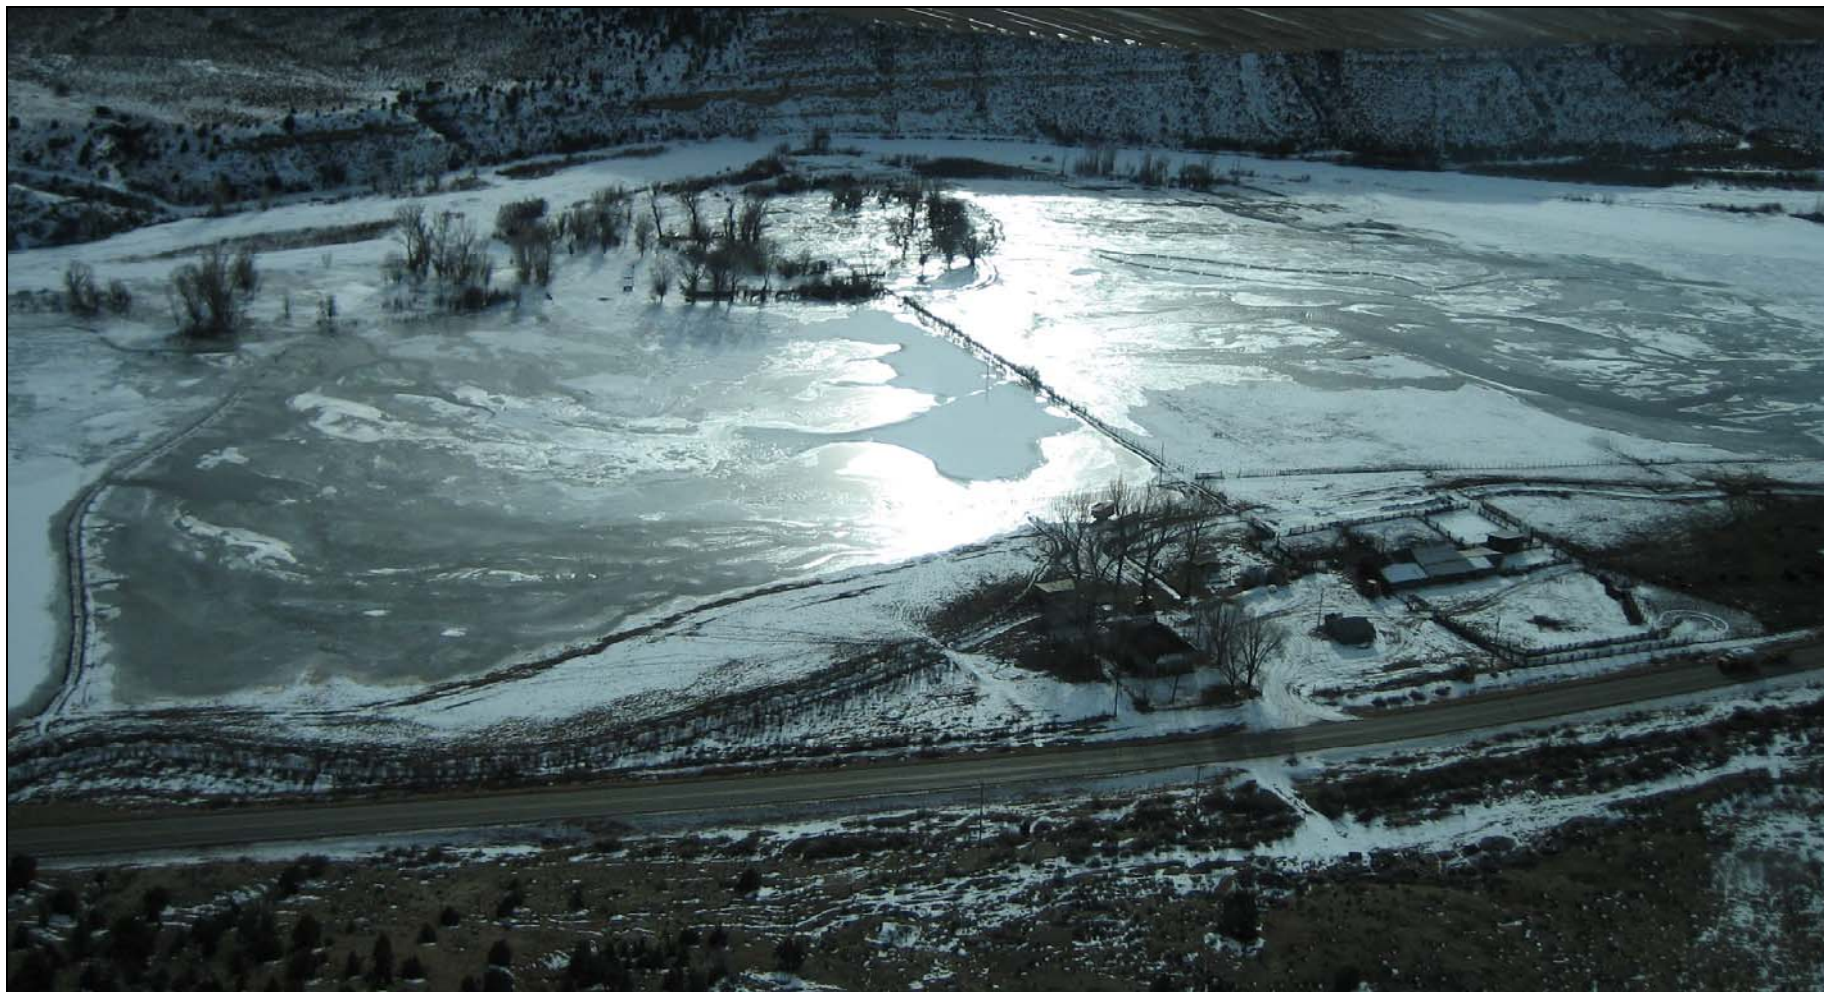
flooded fields owned by Love, and Figure 9 is a general site map. The floodwaters and frazil ice deposits isolated the ranchers' winter hay supply and calving yard. About one mile upstream, the ice jam threatened a steel bridge also owned by Love. Also, thousands of feet of cattle fencing and numerous irrigation structures were inundated and frozen in, the degree of damage unknown until spring.

Figure 8. Flooded fields at Love property on 17 January 2006. Ice jam fills main channel in background.

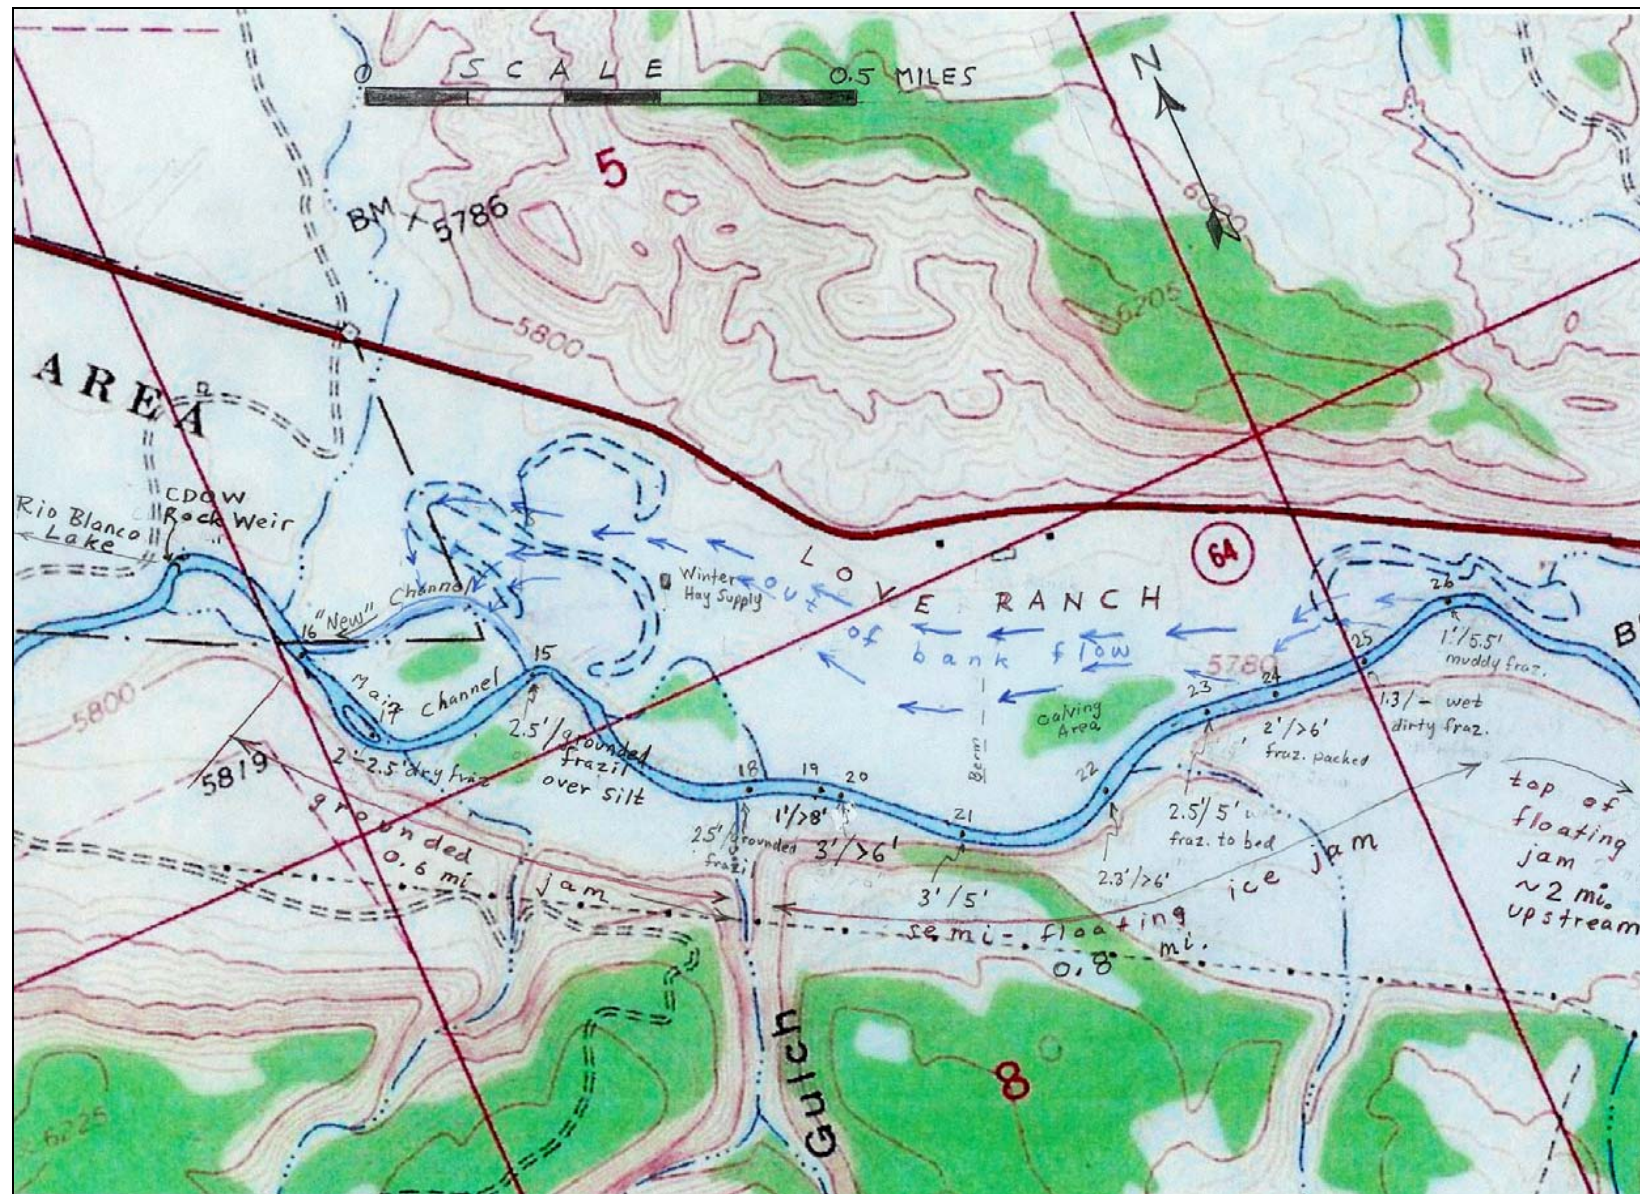
On 18 January, Sam Love and CRREL accessed the jam in the main channel from the west (Waypoint 15, Fig. 13), finding a grounded, dry frazil accumulation about 2.5 ft thick, resting on a silt layer. This silt had apparently deposited under the ice jam, as the river in this area is known to be gravel and cobble-bedded. Looking to the north, overland flow could be seen spilling into the new channel from the fields on the north side of the river.

On the afternoon of the 18th and the morning of the 19th, CRREL accessed the frozen jam on foot to make a series of ice thickness measurements (shown in Figure 13). Ice conditions are described from downstream to upstream. From the CDOW weir to the outlet of the new channel (Waypoint 16), the river was about half-covered by decaying frazil ice, with the full flow of the river passing beneath the ice and within banks. The entire new channel was open, with exposed silty cut banks along the outside of the bends. These eroded banks did not look entirely new, suggesting that this secondary channel captured by the ice jam flood outflow also conveys flow during open-water season high-discharge events. At the upstream end of the new channel, overland flow could be seen re-entering the river at

multiple locations along the right bank over a length of about 600 ft. A grounded jam filled the lowermost 1500 ft of the main channel (Waypoints 16 and 15) and the dry frazil ice accumulation appeared to be draped over the channel bed topography. The ice was 2–2.5 ft thick, with no signs of flow beneath. In the area abeam the Love Ranch buildings (Waypoints 19 and 20), solid frazil 2.5–3 ft thick overlay still, muddy water 6–8 ft in depth.

This semi-floating ice jam condition continued from Waypoint 19 upstream for about a mile to Waypoint 26. At many locations in this section of the main channel, water and loose muddy frazil ice were found beneath the 2- to 3-ft-thick solid frazil layer, but no appreciable water currents were observed. Although it was difficult to discern exactly, flow appeared to be escaping the main channel and into the fields of the Love Ranch for about 1000 ft, between Waypoints 23 and 26. The solid frazil layer probably represented an initial floating ice cover formed of juxtaposed frazil floes. The loose frazil was probably drawn beneath the solid cover and deposited there to thicken the jam. The continued deposition of this frazil, and possibly silt, plugged the flow paths beneath the jam, forcing the river flow out of bank and onto the Love property.

Figure 13. Ice jam thickness measurements.

On about 23 January, Love contracted a high-track D-8 Cat to attempt to excavate a 20-ft-wide channel through the grounded and semi-grounded portions of the ice jam from Waypoints 16 to 26. It was hoped that this would cause the river flow to return to the main channel, alleviating the

upstream flooding. Shortly after accessing the downstream end of the jam, the D-8 got stuck in riverbed silt deposits estimated by Love to be 3 to 4 ft thick. A larger D-9 cat was called in to pull out the D-8. The presence of these thick silt deposits was somewhat of a surprise, as the predominant bed material in this section of river is in the gravel-to-cobble size range. The best guess at this point is that the silt deposition is related to the ice jam. After nearly losing the D-8, the excavation option was called off.

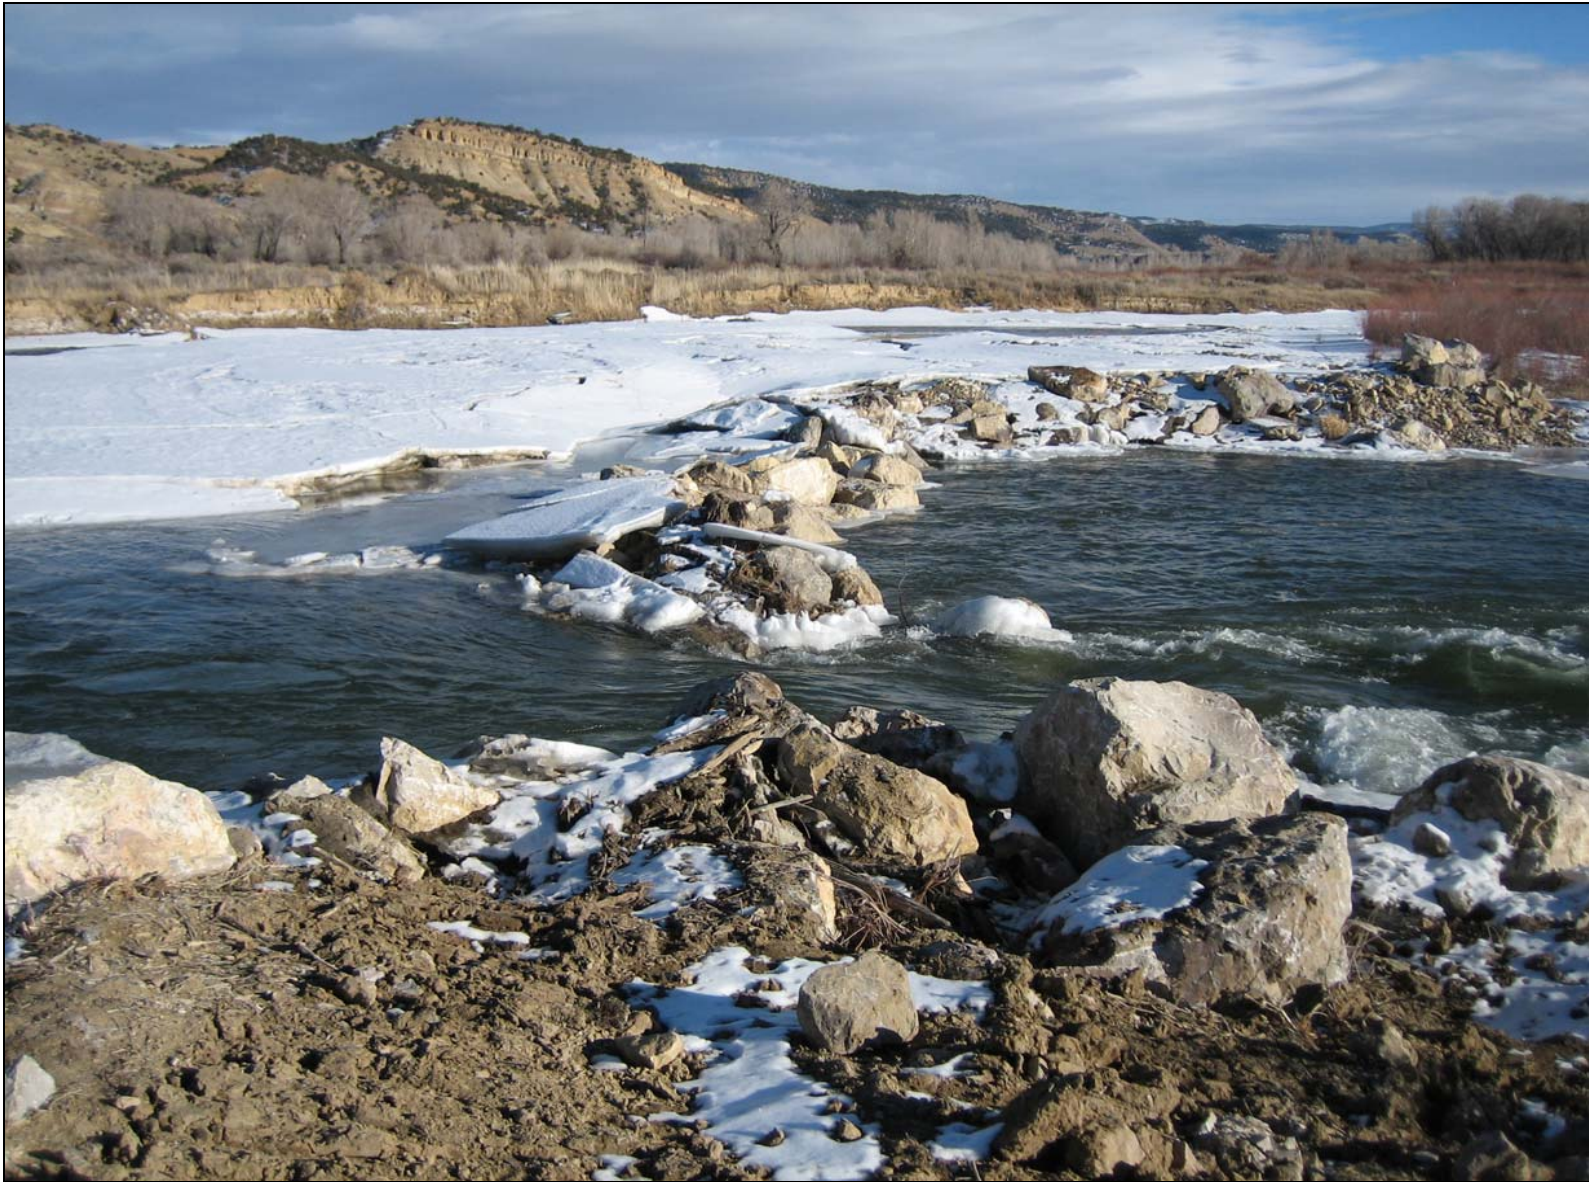
Figure 14. Breached CDOW rock weir, 17 January 2006.

On 10 January, USACE and CDOW allowed Love to remove a section of the weir using a large excavator (Fig. 14). This action, combined with the effect of more moderate air temperatures, caused most of the ice cover to melt out for about one mile above the weir (Fig. 7). The ice jam in the main channel adjacent to the Love Ranch remained in place, however, and continued to divert nearly all the river flow across the Love property.
